Energy Research and Development Division
FINAL PROJECT REPORT

Scalable Near Zero Energy Retrofits in Low-Income Multifamily Housing

March 2019 | CEC-500-2019-021

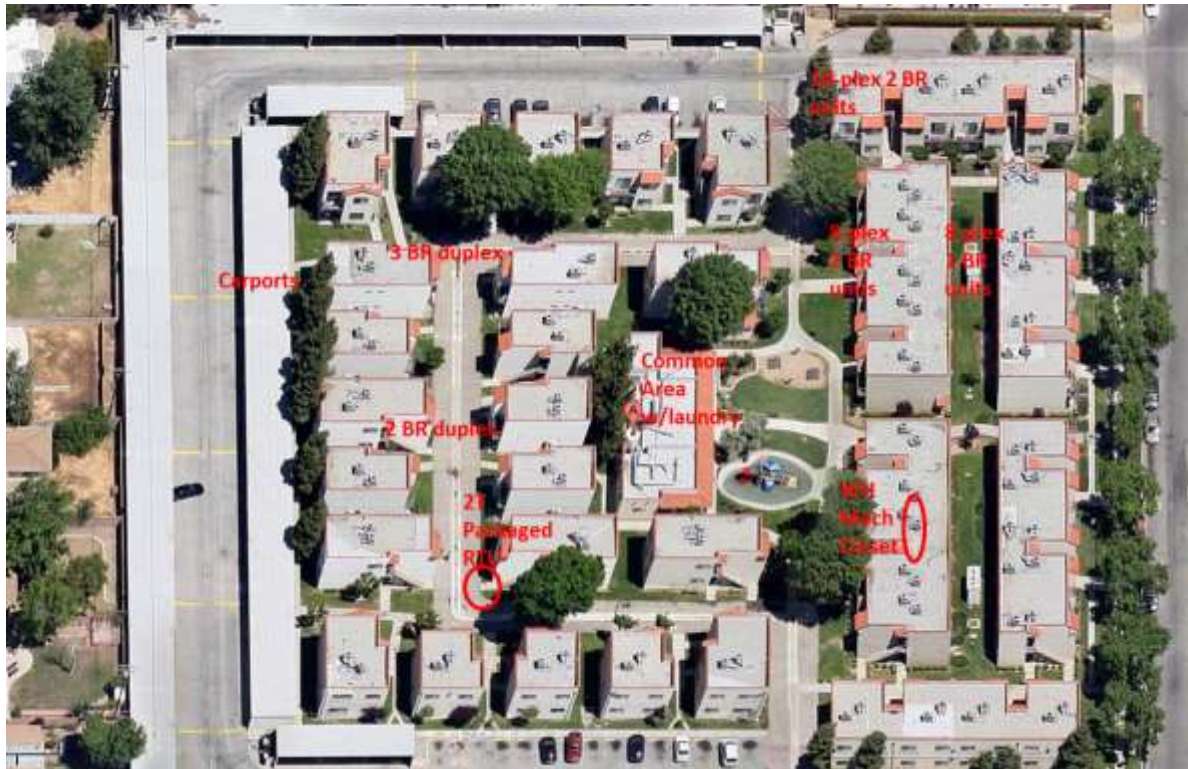
Figure 2: View of Village at Beechwood Property with Key Energy Systems Identified

The project began with an energy audit, which included site visits and a survey of energy use. The research team visited the Village at Beechwood site to collect the data needed to perform building energy simulations, and studied individual Beechwood apartments, ancillary buildings, and the complex as a whole. During site visits, investigators measured the apartments and buildings (Figure 2) and recorded data on energy-consuming devices and equipment. Tests were performed to measure duct leakage using the Duct Blaster, and to measure building envelope leakage using the Blower Door test. Researchers also physically viewed the apartments, including as many of their construction components as possible, allowing a survey of the appliances in several apartments. After developing computer models, another site visit followed to investigate the duct systems in detail.

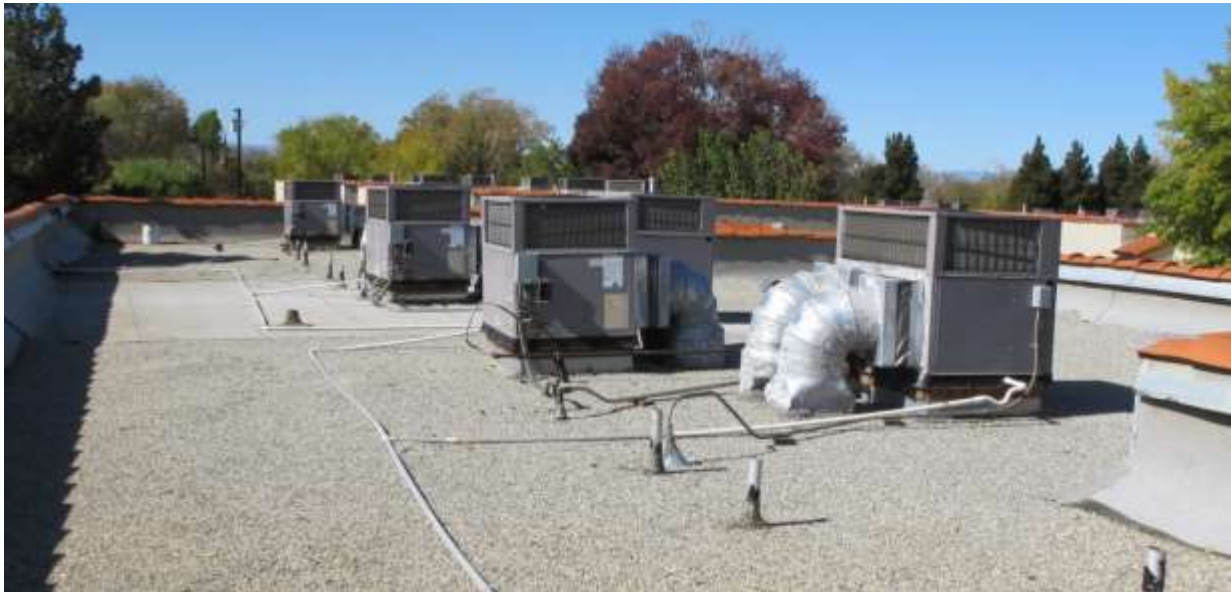
Figure 4: Rooftop Packaged Heating, Ventilation, and Air Conditioning Units on Building 1

The team developed each of the computer models based on actual audited buildings. Upon an initial visit by the research team, the basic construction type was noted, the building dimensions measured. The nameplates of the rooftop units, furnace, and water heater for domestic hot water were pictured and recorded. The roof-mounted packaged heating, ventilation and air conditioning (HVAC) units on Building 1 were rated at 12 seasonal energy efficiency ratio (SEER) and 80 percent annual fuel utilization efficiency (Figure 4). The domestic hot water outbuilding housed two gas-fired 0.82 energy factor 100-gallon tanks, which provide hot water to 26 apartments in Buildings 1, 2, and 3.¹ Figure 5 shows two of the three domestic hot water units per outbuilding. Another identical system provided hot water to Buildings 4, 5, and 6. These systems had circulation pumps activated by demand for hot water that would not run if the water at the tap was already hot. Pumps were behind the tanks, and were not visible. The laundry room was well-equipped with 10 washers and 10 dryers and was located in the backside of the common area (Figure 6). The refrigerators were top-freezer style (Figure 7) and the ranges were standard gas-fired (Figure 8). All windows were double-paned with metal frames (Figure 9). Figure 10 shows the ceiling insulation through a damaged exterior wall, which exposes an estimated two inches of fiberglass batt insulation.

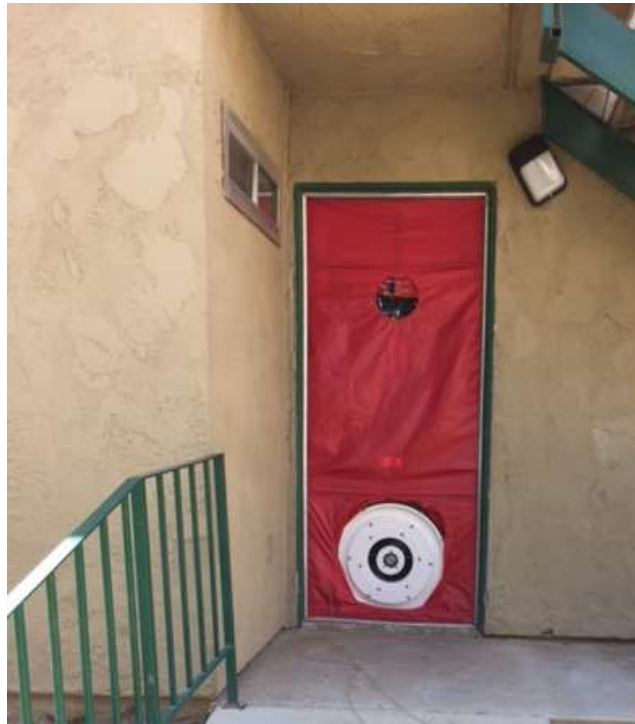
Figure 11: Blower Door Test in Progress

The second site visit included a certified third-party inspections firm and conducted blower door, duct blaster, and flow hood HVAC testing procedures (Figure 11). The tests evaluated the improvement of thermal performance of the apartments to identify impacts on energy bills and occupant thermal comfort. The duct Blaster test measured duct leakage by pressurizing ducts to 25 Pascals (Pa) and recording the cubic feet per minute (CFM) needed to achieve a stable 25 Pa with the pressure-fan sealed to the air return and all supply ducts sealed with tape. The blower door tests to measure leakage in the building envelope were conducted with all windows and doors closed except the front door, where the blower door equipment and fan were installed. The CFM needed to pressurize the apartment to 50 Pa was reported. Table 4 summarizes the results of these tests, which were used in development of the baseline simulation models.

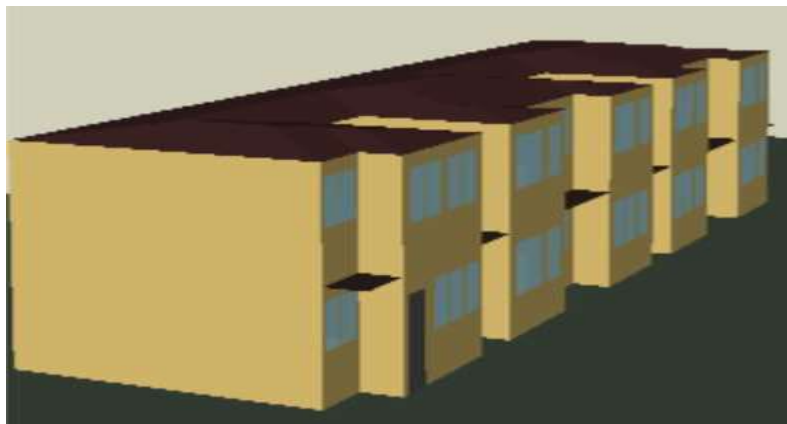
Figure 13: 3D Image of “Built-Up” EnergyPLUS Model Used in Building 2 Simulation

Figure 13 shows the “built-up” model without adiabatic surfaces in a sample rendering of the various units used in the simulation.

At the end of the project, the team was able to simulate the entire building using a later version of the energy modeling software, BeOpt v2.6.0.2, discussed in Chapter 6.

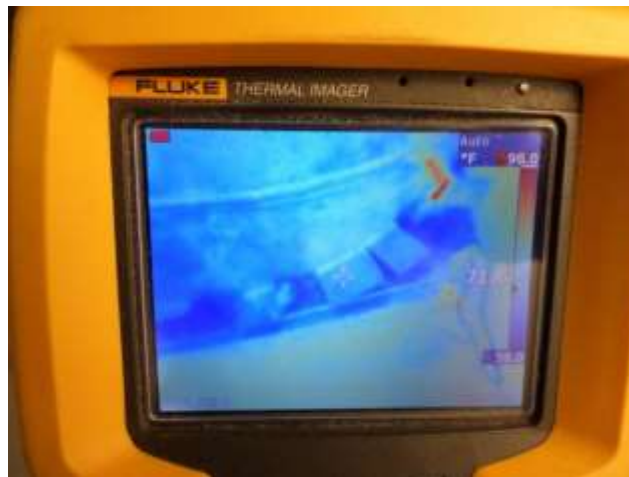
Figure 22: A Screen-Shot of Thermal Camera

Visual inspection of the original ducts found tears in the flex duct and the leakage was noticeable with the thermal imaging camera. The thermal camera also detected leakage at register boots in both apartments. Smoke tests, performed separately in each apartment, resulted in smoke filling the chase cavity and hallway area. Visual inspections of the inside of the return in apartment 17, using a flashlight found gaps at the connections of the ridged pipe of the return-duct system (Figure 23). The return from the downstairs apartment runs through the interstitial space around the upstairs apartment, and when the smoke test was performed on the downstairs apartment, smoke leaked into the upstairs apartment (with the ceiling removed) via the leaks and interstitial-space connections.

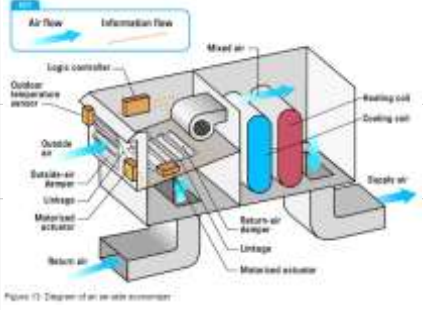
ET Measures	Tech Description	Pros	Cons	Barriers to test	Website	Figure
Rooftop unit with economizer control	Dry Bulb Economizer	When there is a call for cooling, a temperature sensor determines if outside air is at or below a certain temperature setpoint (e.g., 55°F), the outside air damper is controlled allowing more outside air coming in to be mixed with return air to provide cooling.	1. Demand control ventilation to provide fresh air when CO ₂ is high 2. Electric energy saving by cooling with outside air thus reduce mechanical cooling	Outside air may be low enough in temperature but may be too humid for occupant comfort.	Tech Description: [1]. Steven T. Taylor, Hwakong Cheng. Economizer High Limit Controls and Why Enthalpy Economizers Don't Work. "http://www.cmfrih.com/documents/ASHRAE_Journal_QA.pdf". November 2010 [2]. Airside Economizer. http://www.energystar.gov/index.cfm?c=power_mgt_datacenter_efficiency_economizer_airside

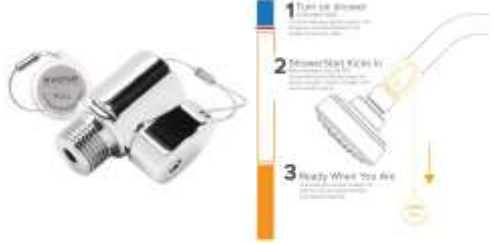
ET Measures		Tech Description	Pros	Cons	Barriers to test	Website	Figure
Shower Start		The thermostatic shut-off valve allows the shower to save the hot water when it becomes warm for the people (behavioral waste)	1. Eliminate behavior waste by saving water and energy during shower warm-up. 2. Does not interfere showerhead's feel or flow. 3. Compatible with virtually all showerheads and shower arms (1/2" NPT fittings) 4. In California, 10%	Refer to customer reviews on Amazon. Negative comments mostly come from : 1. Reliability 2. Customer service [comment referred to Amazon customer review]	Hard to establish a baseline to quantify the energy savings. Because taking shower is customer behavior related and is hard to find an exact baseline	Tech Description: http://thinkevolve.com/shop/showerstart-tsv/ Product:

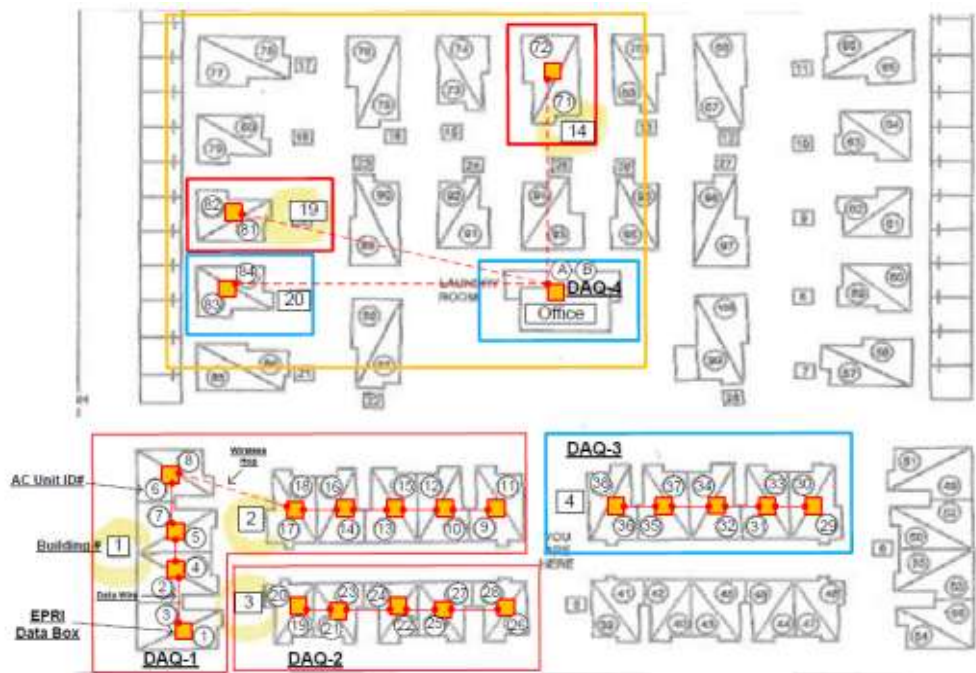
Figure 26: Data Monitoring Plan for Village at Beechwood

The data acquisition and monitoring portion of this project required a site-specific strategy that collected data from multiple sources into a “data warehouse” to support analytics. The Beechwood Complex had 100 apartments, as shown in Figure 26.

The buildings outlined in red were the 32 test-case apartments for data monitoring, and the buildings outlined in blue were the 14 apartments to be monitored as baseline and the common area. The data acquisition plan consisted of systems to collect and deposit data which was then analyzed by the research team. The systems included: 1) Electric Power Research Institute (EPRI) data acquisition system; 2) non-intrusive load monitoring system for building-wide electric load monitoring; 3) datasheets of field tests; 4) natural gas use data from Southern California Gas Company; 5) solar PV data; 6) smart thermostat data; and 7) electric consumption and billing data on WegoWise. The systems are discussed in more detail below.

The team installed the EPRI data acquisition system in 46 apartments and required 23 data monitoring boxes since each system monitors two apartments. The 46 apartments included all 28 apartments in Buildings 1, 2 and 3; Building 4 monitored as a control unit; and Buildings 14, 19, 20, and 21. Referring to Figure 26, data acquisition (DAQ) 1, DAQ-2, DAQ-3, and DAQ-4 were

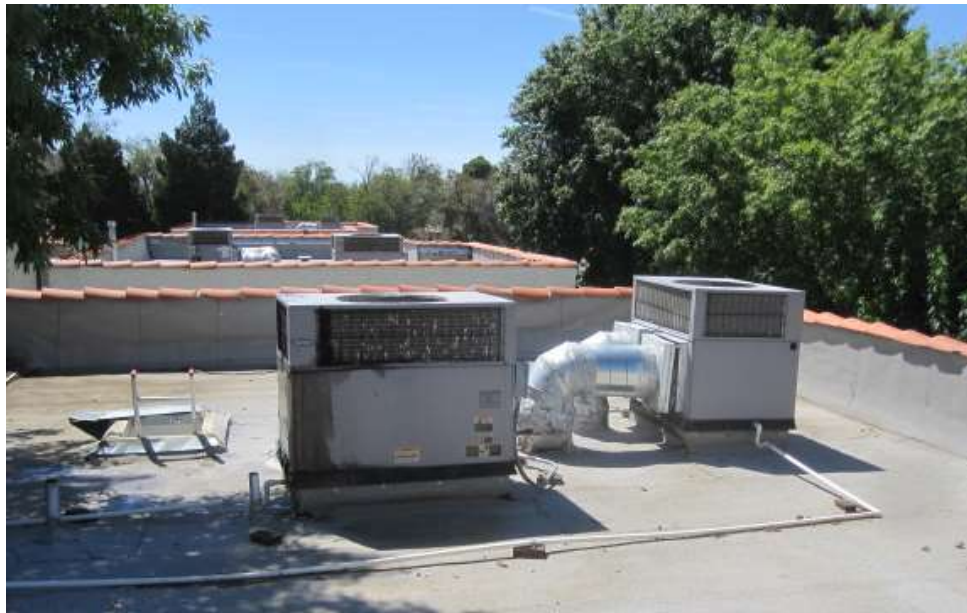
Figure 28: Air Conditioning Units on a Duplex Unit

The air conditioning (AC) units were labeled with the apartment's number, and each duplex had two rooftop AC units, as shown in Figure 28. In addition, the data-collection box was also assigned with a number (in yellow background with red border). Thus, a box ID of "1 B4 U29, 30" represents the data collection of collection box #1 (located in building complex 4) from apartments 29 and 30 (the duplex on the right in Figure 29).

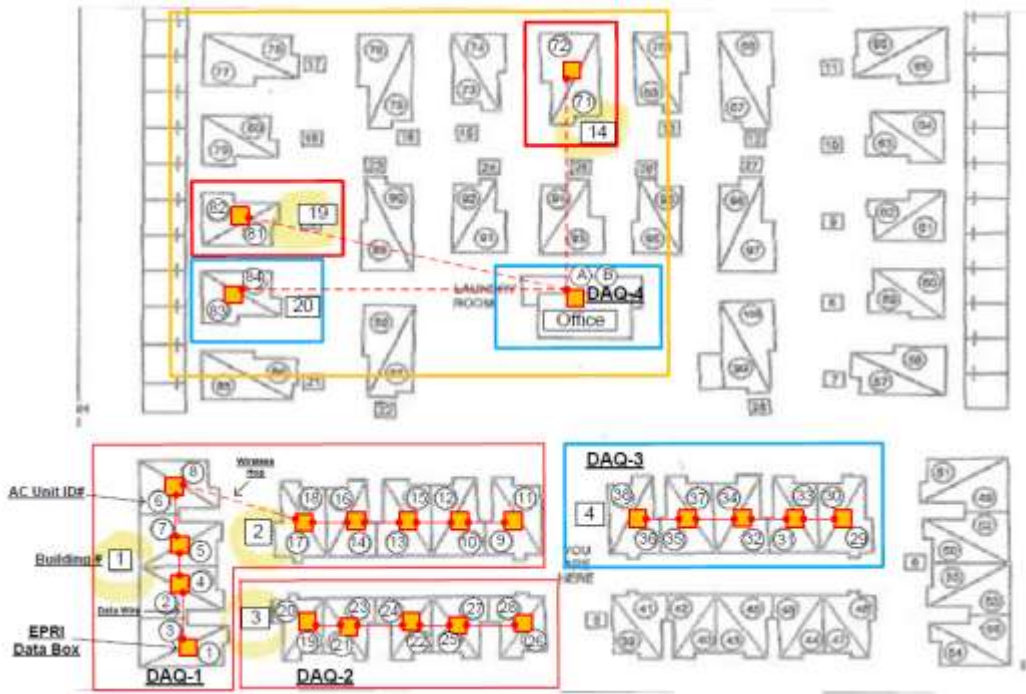
Figure 31: Overview of Data Acquisition System Layout

As mentioned earlier, the data acquisition boxes covered 30 apartments and the common area as the treatment group, plus the 10 apartments as the control group. Figure 31 illustrates the data acquisition systems that gathered data from the apartments and transmit the data to EPRI's database. The solid line connections shown in the figure are dry contacts (hard-wired connections), and dashed lines represent wireless data transmission. The electrical data of rooftop units (voltage, current and real power), the outside air conditions (temperature and relative humidity), temperature readings in the ducts (supply air, return air and exhaust air of each apartments) and the flow rates and temperature readings of the solar thermal system were recorded in the EPRI database and were made ready for download.

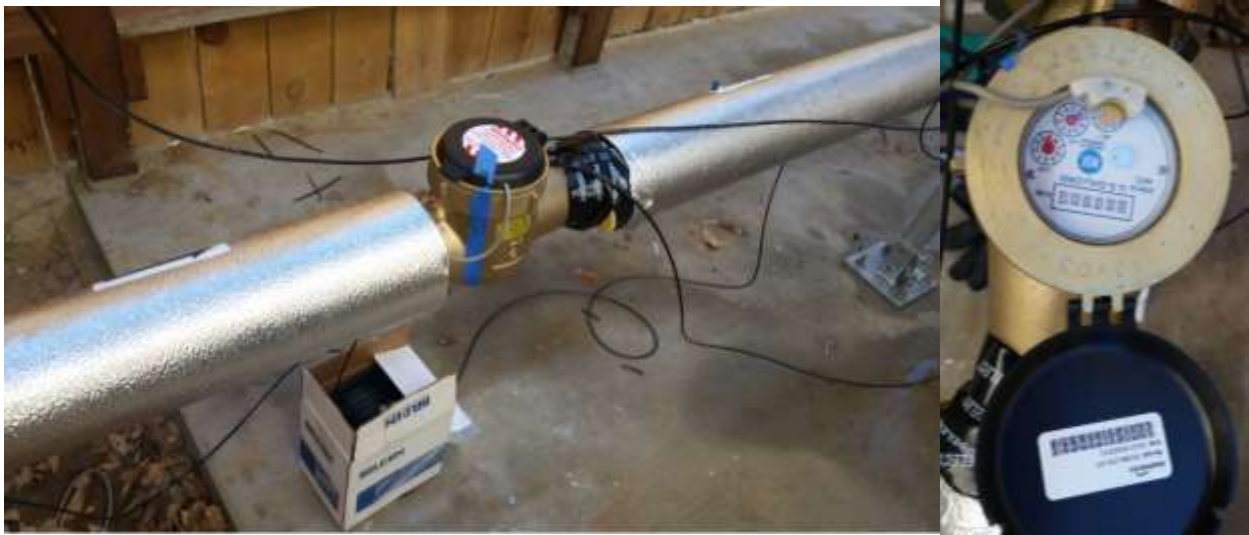
Figure 33: Water Flow Meter Data Collected at Community Water Heating System

The hot water flow between solar panel and water tank was measured by Amatis flow meters (Figure 33), which were installed by Everyday Energy, monitored both solar thermal and solar PV data.

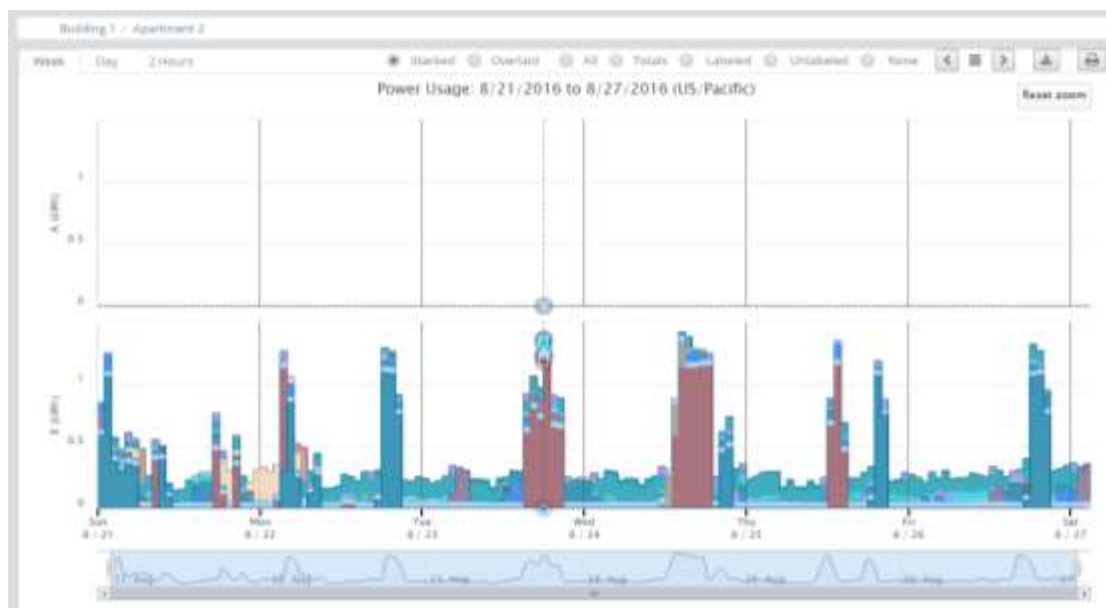
Figure 35: Non-Intrusive Load Monitoring System Collected Data on Building 1

electrical distribution panel using high-frequency sampling sensors and used relevant algorithms to analyze the home's energy use. The LoadIQ's EI. X series is a cloud-based platform using software to identify and track energy consumption and power quality for specific loads. The total load was disaggregated for specific load's energy use, such as for lighting, plug and HVAC loads. As the sensors were located on the main electrical panel, this equipment was not intrusive to the homes/buildings. LoadIQ installed two EI.4 units at the center panel for each bank of four utility meters. Each EI.4 had four measurement "lines". Each line measured a single apartment, featuring two current transformers rated for measuring each phase (A/B) downstream of each utility meter. The data collected on loadIQ NILM system is shown in Figure 35.

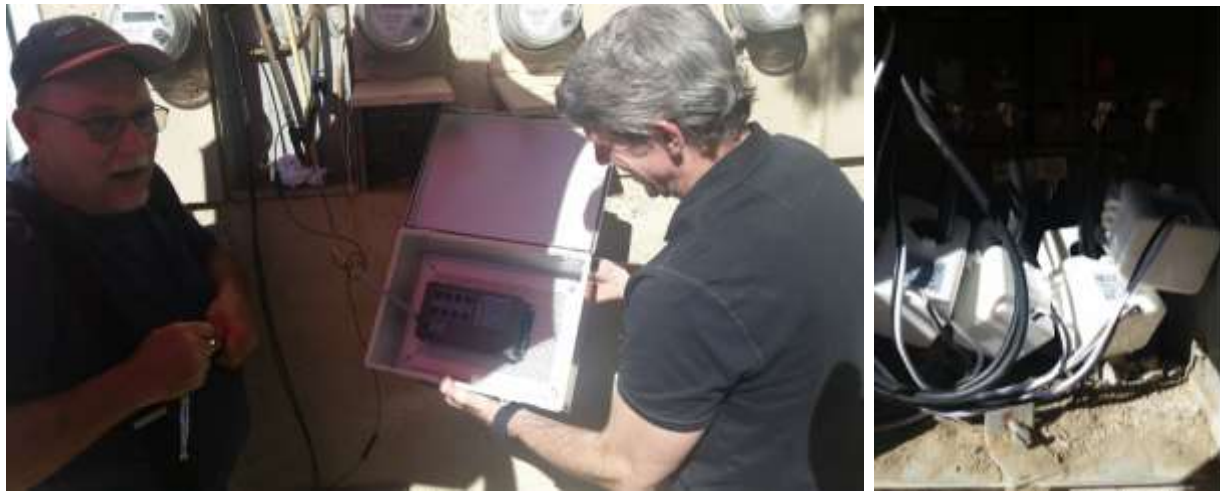
Figure 36: Retrofit process of Non-Intrusive Load Monitoring System

Figure 36 shows the installation of NILM system. The NILM system was installed on Building 1 (8-plex) and was monitoring apartments 1-8 until the hotspot lost its connection. The NILM system collected data through CTs to monitor the total energy use of the residences and disaggregates to individual loads types. The metered data was uploaded to LoadIQ's cloud through wireless internet connection, in this case using a hotspot located in the case with LoadIQ's ELX.

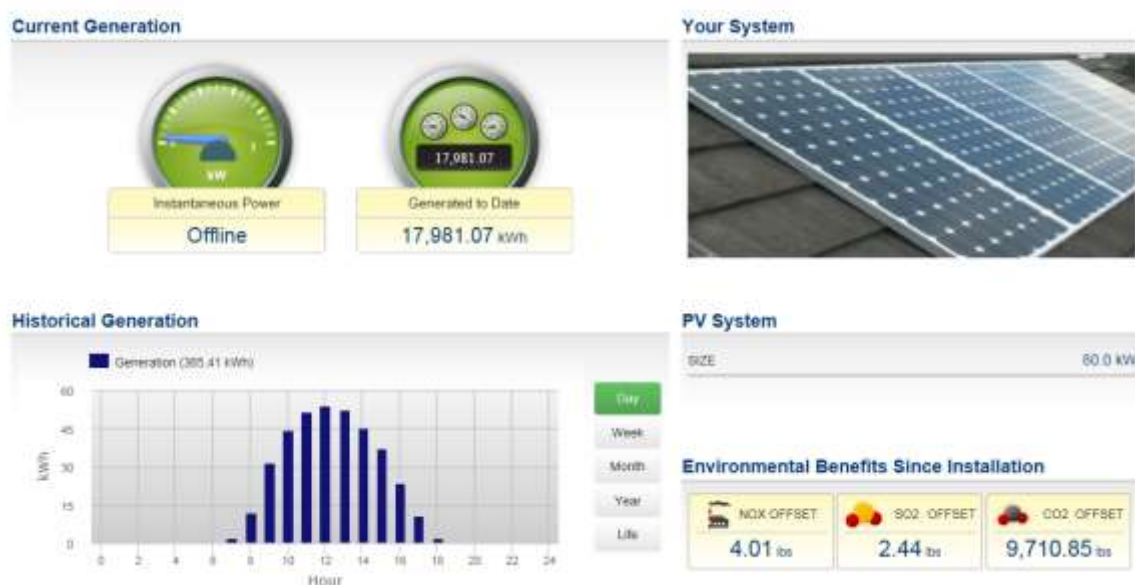
Figure 38: Solar Photovoltaic System and the Data Monitoring System User Interface

The multifamily rooftops can be a valuable real estate space and add extra value by providing electricity from renewables such as PV. Beechwood, like many communities, provides rooftop for mounting PV and solar thermal system not only on the apartments but also on the parking structures. This project retrofitted 30 apartments and thus the PV system was sized to cover the 30 apartments towards zero-net energy; however, the system is connected to provide electricity for the entire community. The research team conducted data analysis for this community solar system as if they were installed for individual units (for the 30 apartments) for ZNE. Figure 38 shows portions of the PV system and the corresponding monitoring interface.

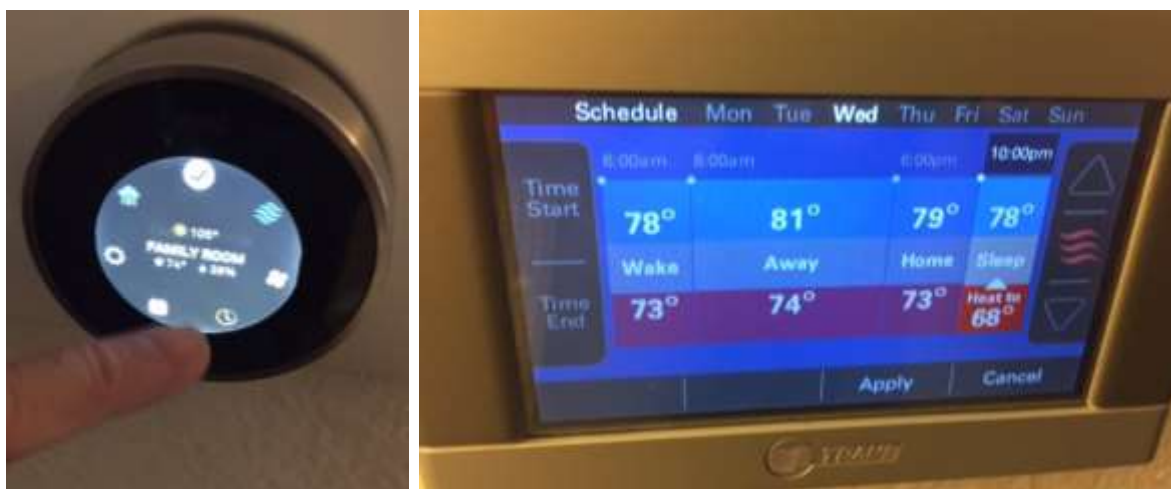
Figure 46: Installation and Commissioning of Home Energy Management System

Smart thermostats were installed as the center piece of the HEMS system (Figure 45). The HEMS ecosystem allowed control of many points from the interface of the thermostats, such as lighting control, security control and blinds control in addition to the primary function of allowing users to set climate control schedules on the user interface directly or from their smart phones remotely. Ecobee, Trane Nexia and Nest Thermostats were installed in the apartments (10 of each brand) and their installed pictures is shown in Figure 46. The HEMS system was designed to collect data on occupant interaction (such as thermostat temperature

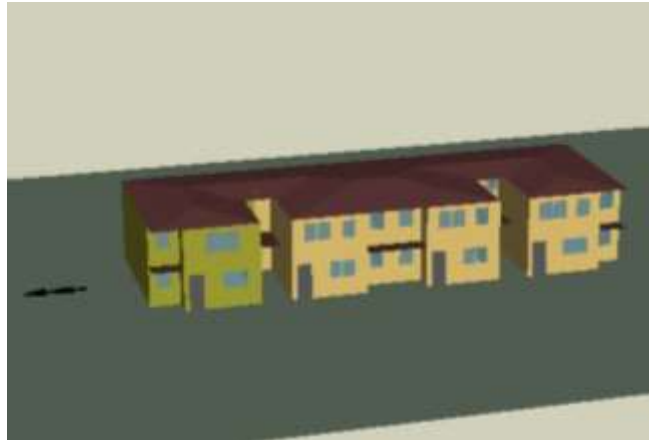
Figure 55: 3D Rendering of Building 1 (unit 1-8)

four stories. Version 2.6 can also provide a rendering of the building, which can be useful in checking the simulation input data (Figure 55). Using the simulation results from the hourly models, the team investigated the impact of various EE measures on the improved baseline features.

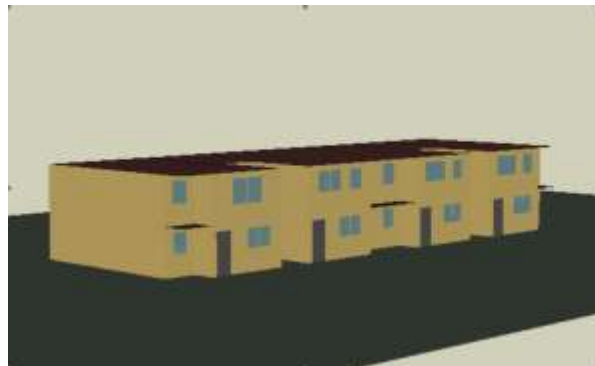
Figure 59: 3D Rendering of Building 2 (unit 9-18)

As with Building 1, Building 2 was also modeled simulated using BEopt v2.6. A graphical representation, generated using BEopt is shown in Figure 59. Using the simulation results from the hourly models, the team investigated the impact of various EE measures on the improved baseline features. See below for the site energy impacts of the individual EE measures on the Building 2 baseline model.

All the other characteristics for the analysis of the result for the Building 2 model are the same as for the previous model.

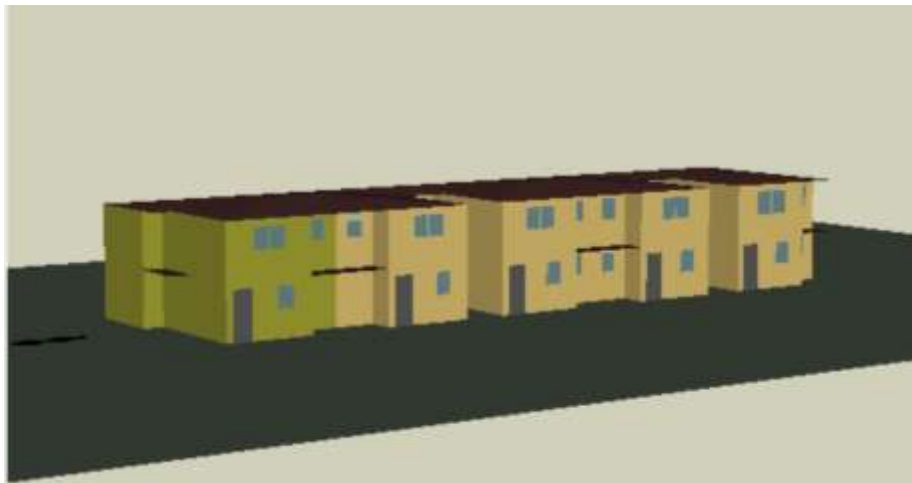
Figure 63: 3D Rendering of Building 3 (unit 19-28)

Building 3 was modeled using the analysis outlined above for the previous two models. A graphical representation of Building 3, generated using BEopt, is shown in Figure 63.

Building 3, unlike the other two buildings, had spray-foam insulation and a protective layer added to the roof, in addition to adding a solar hot water system. The simulation results were then treated in the same manner as the previous two models. The site energy impacts of the individual EE measures on the Building 3 baseline model are shown in Figure 64.

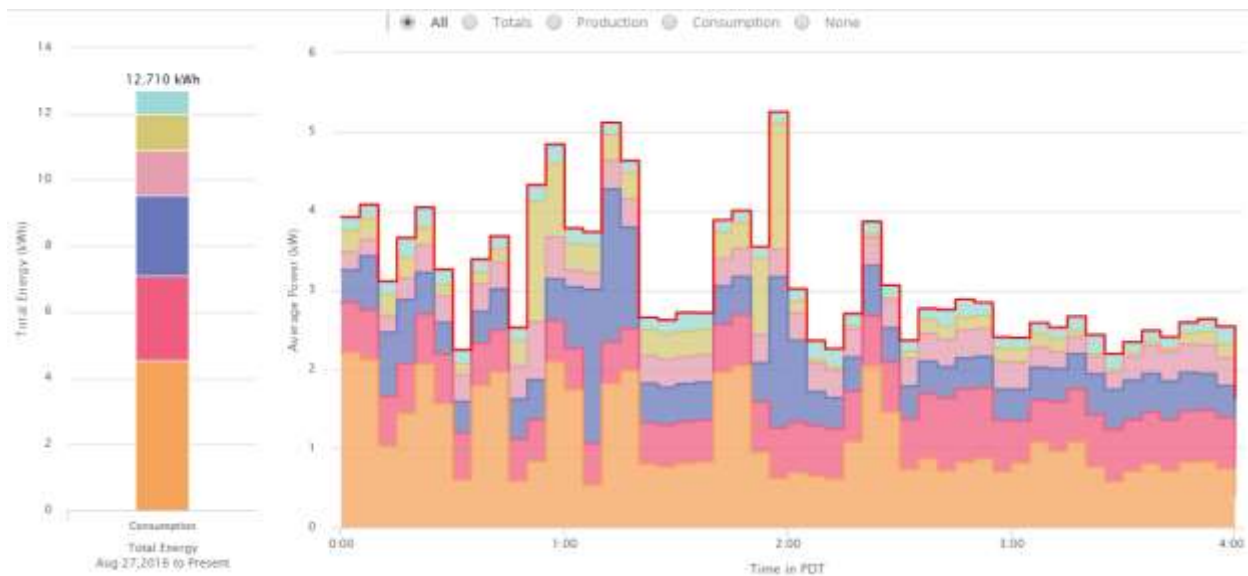
Figure 88: Non-Intrusive Load Disaggregation Using Building 1 as a Pilot Building

Building 1 was employed as a pilot test site to test non-intrusive load monitoring technology for proof of concept (Figure 88). The technology was typically used for commercial buildings or single-family homes, and it was the first time deployed in a multifamily building to disaggregate the load for load analysis.

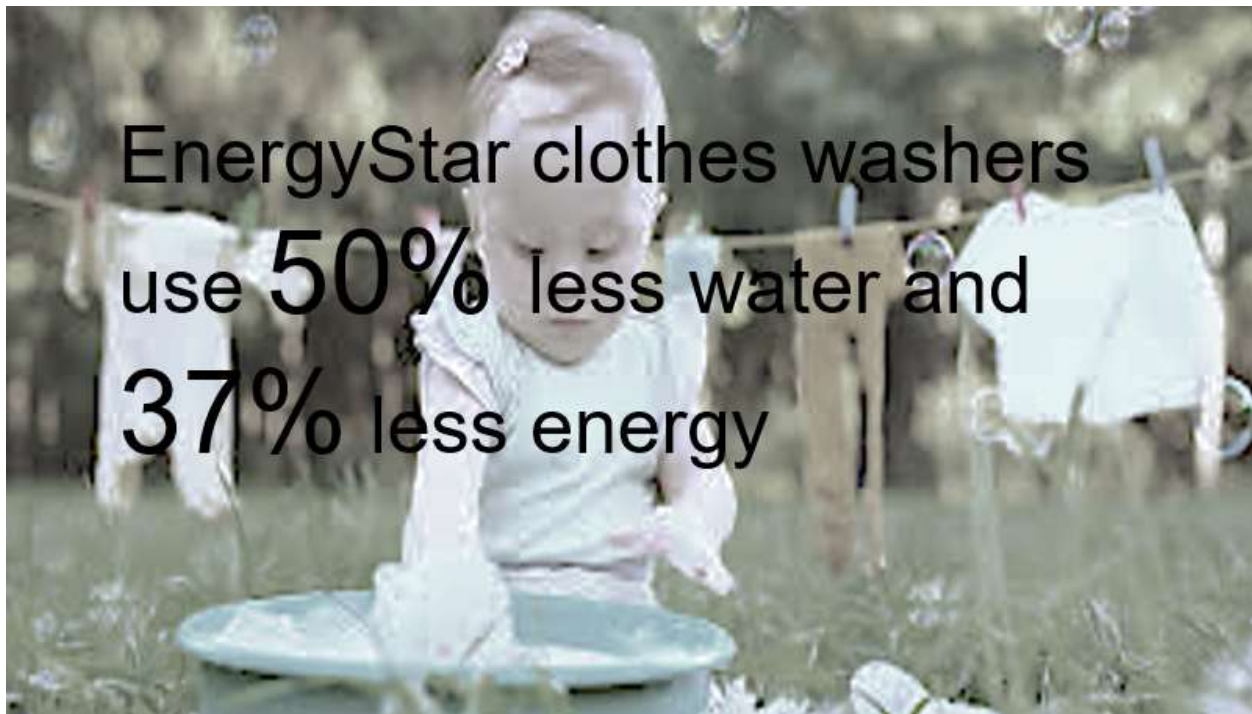
Figure 122: Water Use in Washing Machines

One area many people overlook for water reduction is washing machines (Figure 122). The presenter mentioned that if the community has centralized laundry rooms, even if the supply and maintenance of these machines is outsourced, the utility costs are typically paid under the property's operating costs. Requiring vendors to supply energy efficient equipment will help keep the costs down, both for the water, and the energy to heat the water.

The presenter mentioned that one way to take this a step further is to consider encouraging cold water washing to reduce energy use. A study conducted by the Alliance to Save Energy showed that in locations where there was a price variation for cold, warm and hot water washing, with the cheapest price offered for the cold water wash, energy use could be reduced by as much as 30 percent.

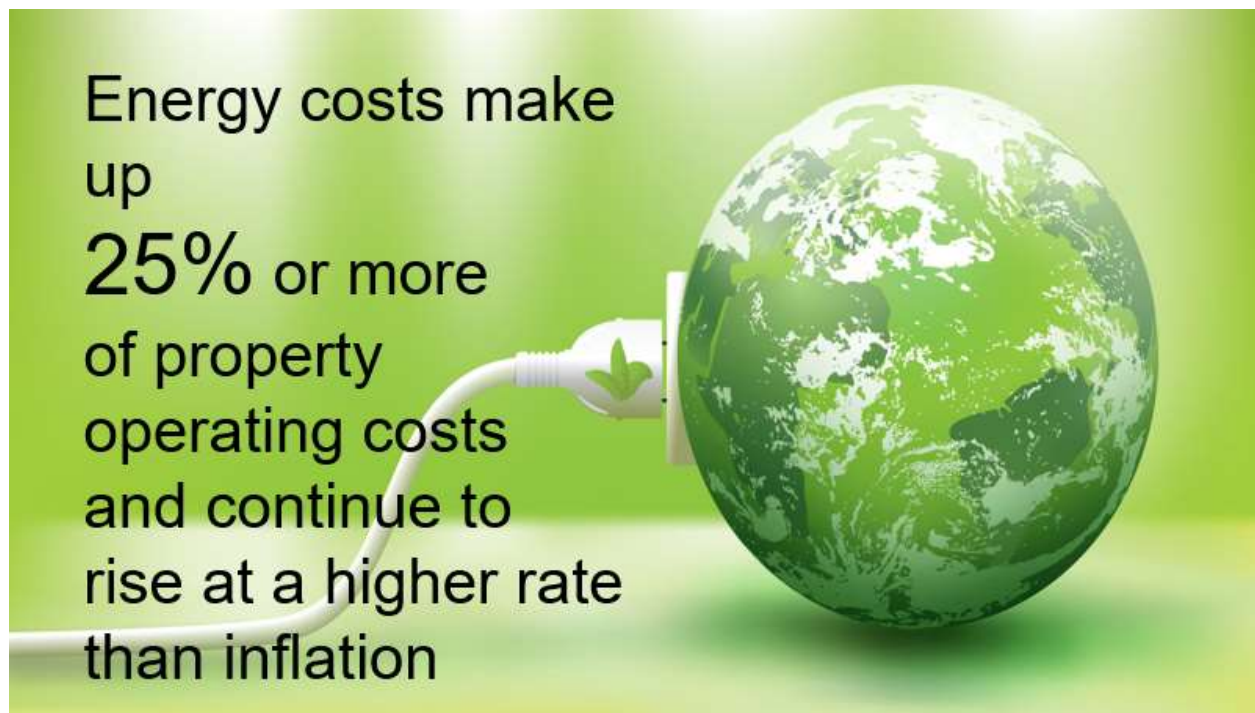
Figure 123: Cost of Energy

Commercial electricity rates increased an average of more than 7 percent just from 2013 to 2014. Natural gas pricing has increased at about 5 percent per year, and these trends are expected to continue with no drop off in sight (Figure 123).

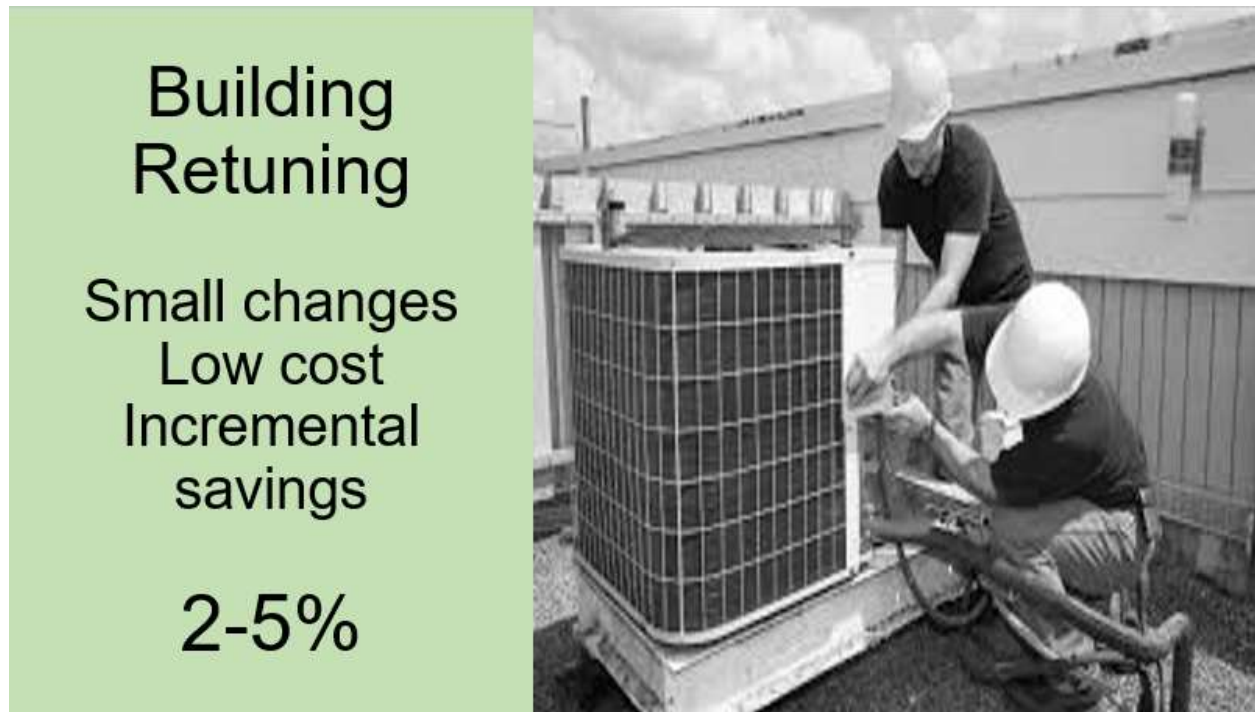
Figure 125: Building Retuning

Another opportunity more people are taking advantage of is retrocommissioning, or some people referred to as “building re-tuning” (Figure 125). Some say that up to 20 percent of the energy used in commercial buildings is wasted because of improper operations. Building re-tuning provides a way to have an immediate impact, especially in the often-overlooked small building market, which includes many multifamily buildings. Small buildings are usually those under 100,000 square feet that frequently do not have any centralized building automation systems. These buildings often have package units for heating and cooling, and are controlled by zone thermostats.
